Phase I Environmental Site Assessment

January 25, 2024
BEST Job #: 24-014

Lakeridge Resort

8651 Ohio 368
Huntsville, Ohio 43324

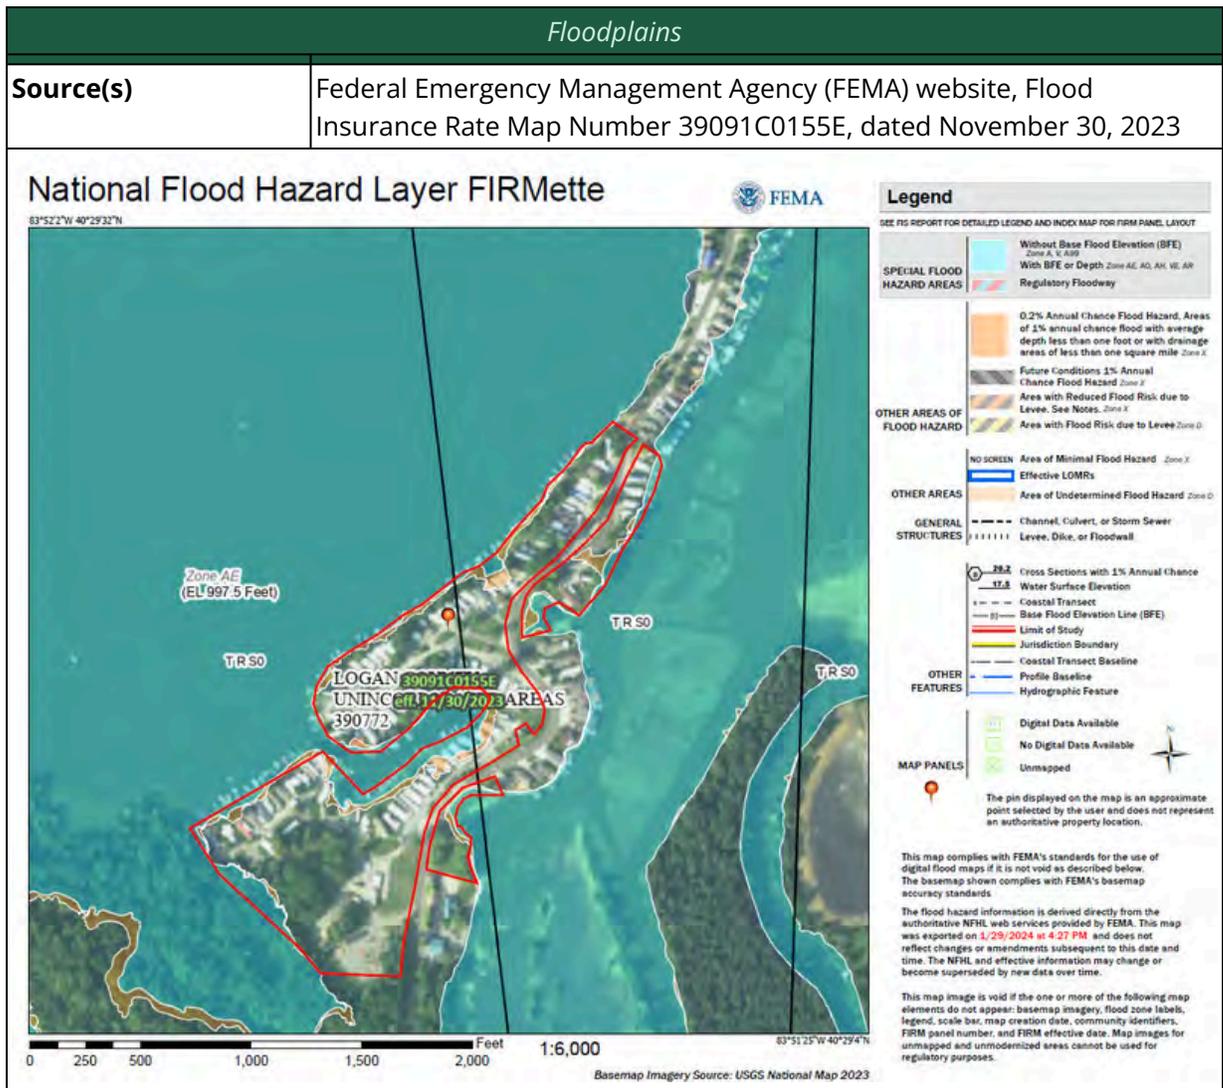
<i>Floodplains</i>	
Floodplain and Flood Zone Designation(s)	<p>Zone X (unshaded), not located within a 100-year floodplain or a 500-year floodplain, and has no special associated flood hazards</p> <p>Zone X (shaded), located within a 500-year floodplain</p> <p>Zone AE, located within a 100-year floodplain</p> <p>Since portions of the subject property are located in a 100-year floodplain and a 500-year floodplain, BEST recommends that the property review their current insurance coverage to confirm that they have the appropriate coverage.</p>

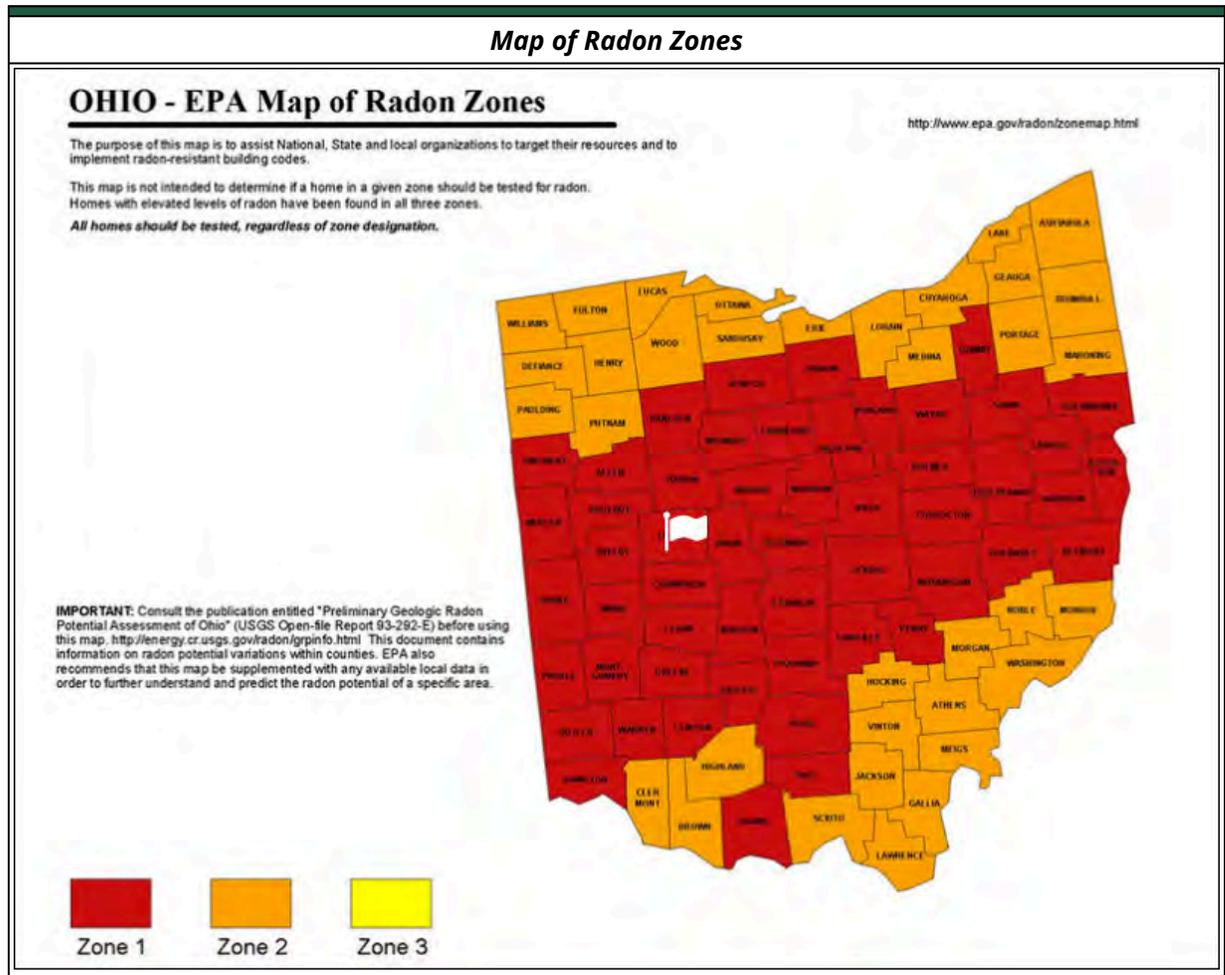
BEST reviewed the US EPA's Map of Radon Zones for Ohio, prepared by the Radon Division of the Office of Radiation and Indoor Air of the US EPA, dated September 1993, for information regarding radon potential at the subject property. Review of this map reveals that the subject property is located in Zone 1, which has a predicted average screening level of greater than the US EPA action level of 4.0 pCi/L.

Freddie Mac guidelines list "Manufactured Housing Communities" as an exemption to the current radon testing requirements. Therefore, no further action regarding radon is necessary at this time.
